I-66 Pavement Rehabilitation

**Fall Asphalt Conference
Richmond, VA**

David Shiells, P.E.
Virginia Department of Transportation

October 2, 2012

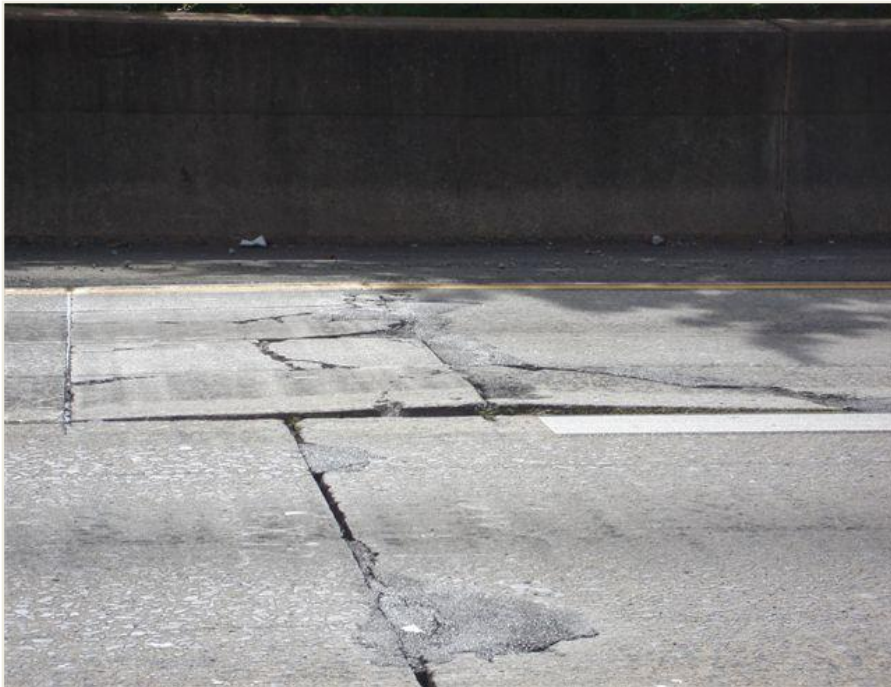
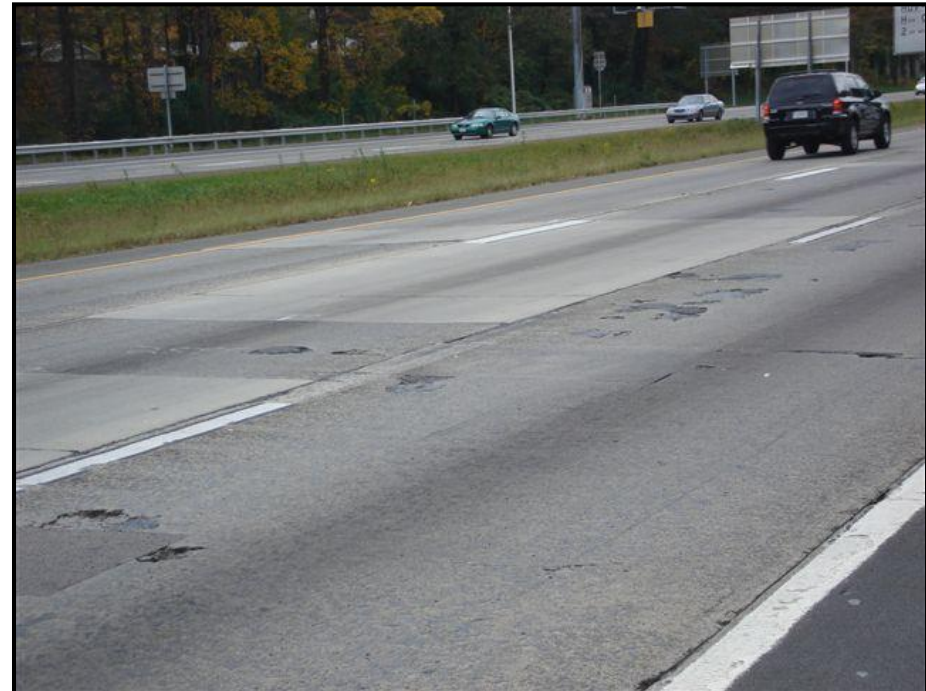
Pavement Condition

- Old Pavement in Poor Condition
 - Approximately 20% of total pavement area in poor condition
 - Distresses generally at transverse joints
 - Isolated slabs have distress (spalling) throughout

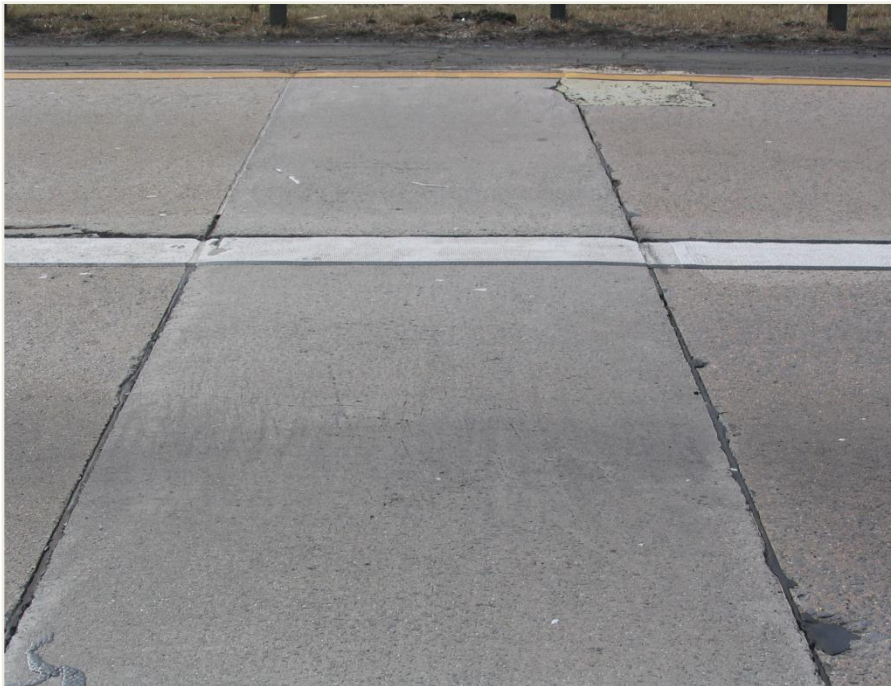
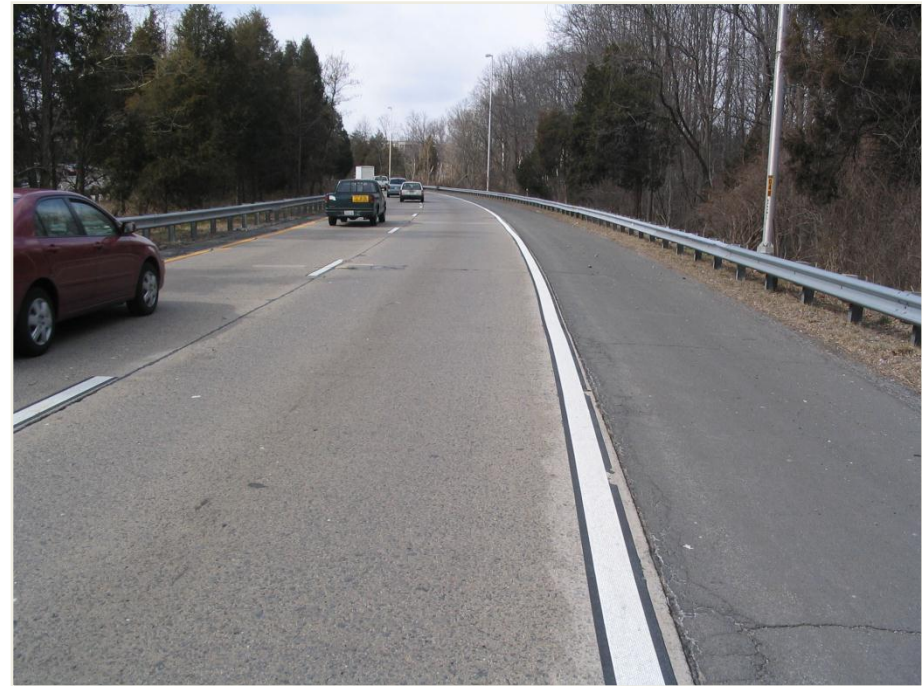
Pavement Condition

- Significant Amount of Good Pavement
 - Some pavement is in good condition
 - Some patches in good condition
 - Pavement in good condition between transverse joints

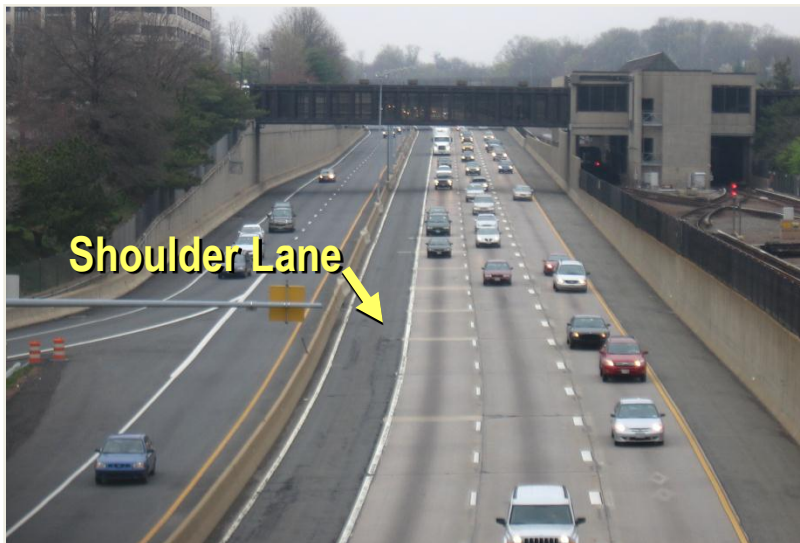
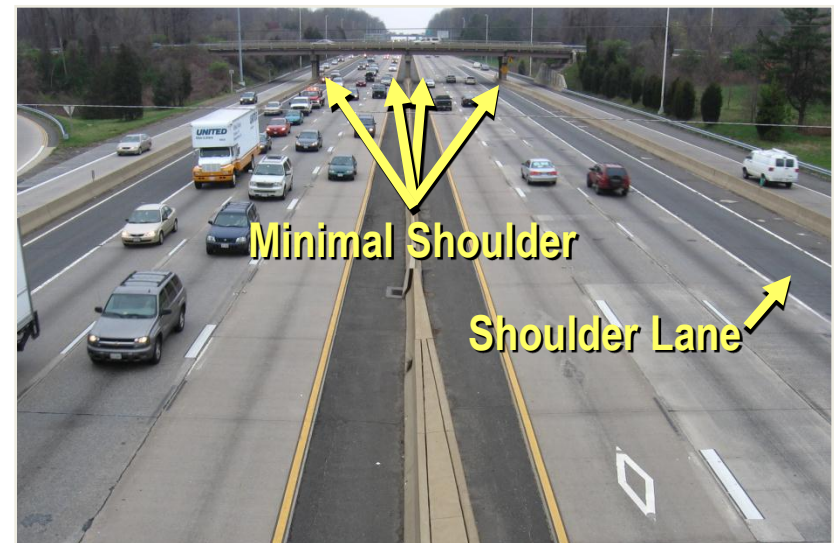
- Limited Space for Maintenance of Traffic
 - Outside shoulder is currently used as travel lane in peak hours (5:30 am to 11:00 am EB and 2:00 pm to 8:00 pm WB)
 - Inside shoulder is only 2'-8' wide
 - No shoulders at some bridge locations; no shoulders on CD road at Nutley Street (retaining walls)

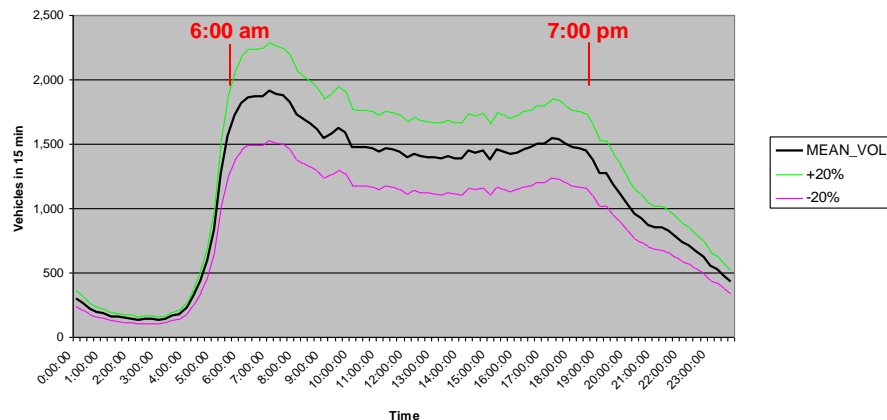
Average Volume in 15 minutes at Det 392 Group at MP 59.11
(EB Friday)

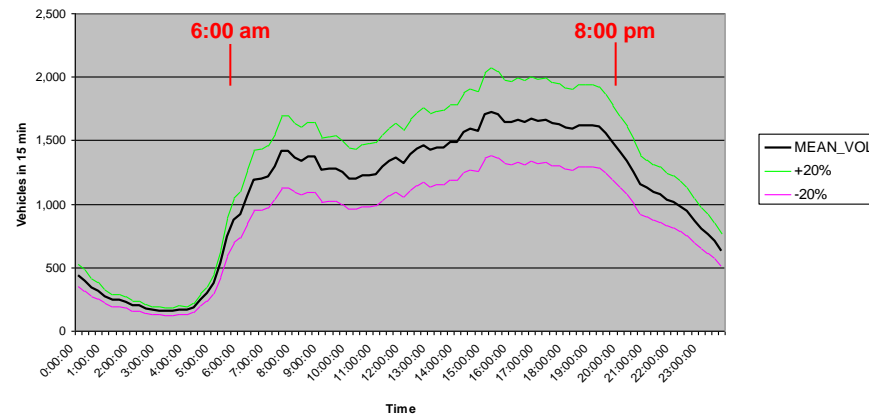
Average Volume in 15 minutes at Det 411 Group at MP 61.43
(WB Friday)

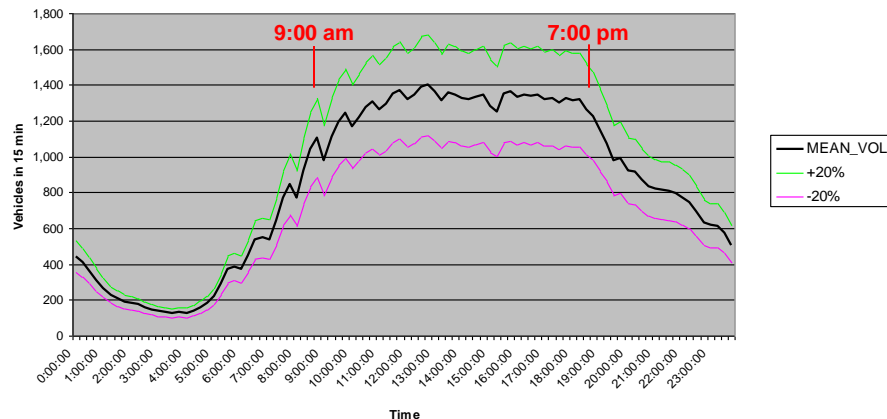
Average Volume in 15 minutes at Det 392 Group at MP 59.11
(EB Saturday)

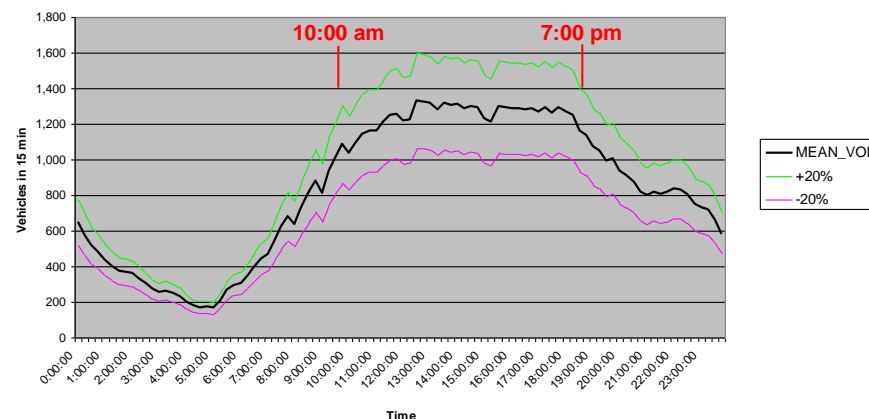
Average Volume in 15 minutes at Det 405 Group at MP 63.74
(WB Saturday)

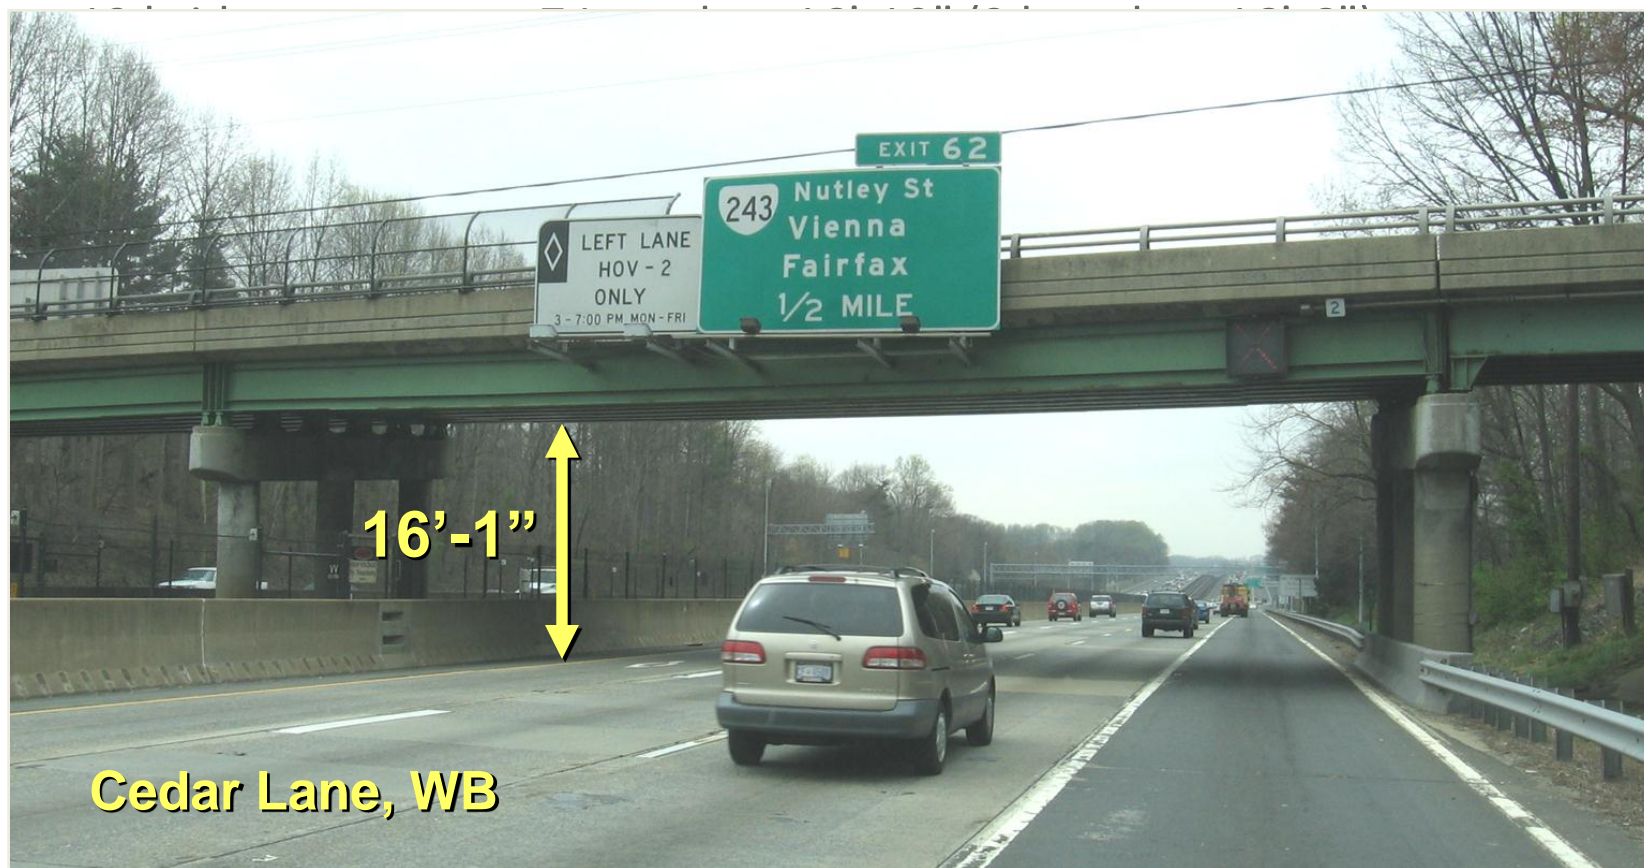
- Limited Overhead Clearance for Existing Bridges

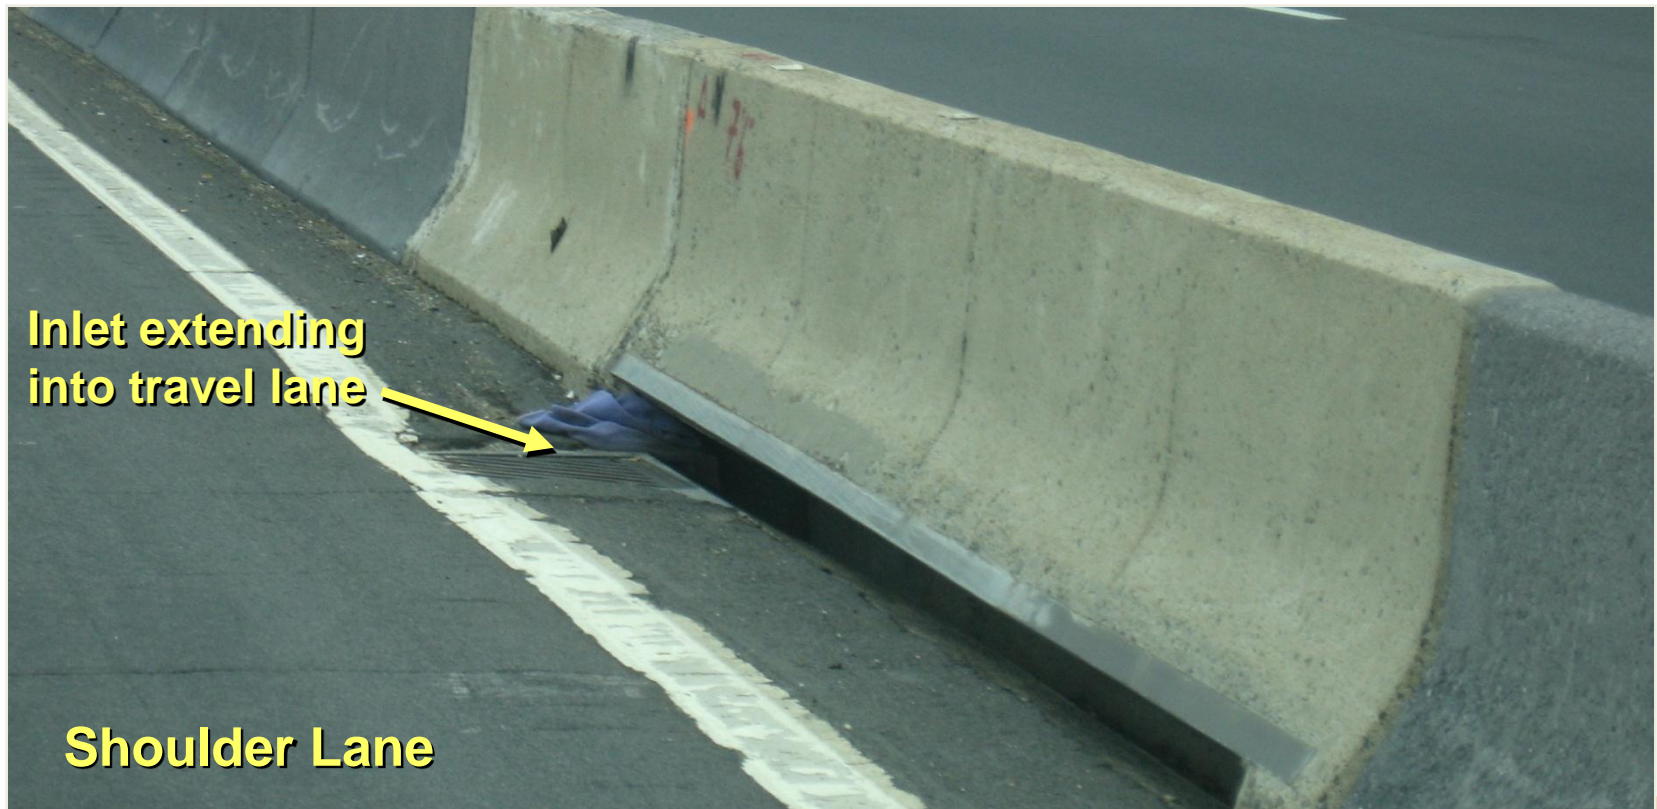
- Drainage
- Inlets extend into shoulder travel lane

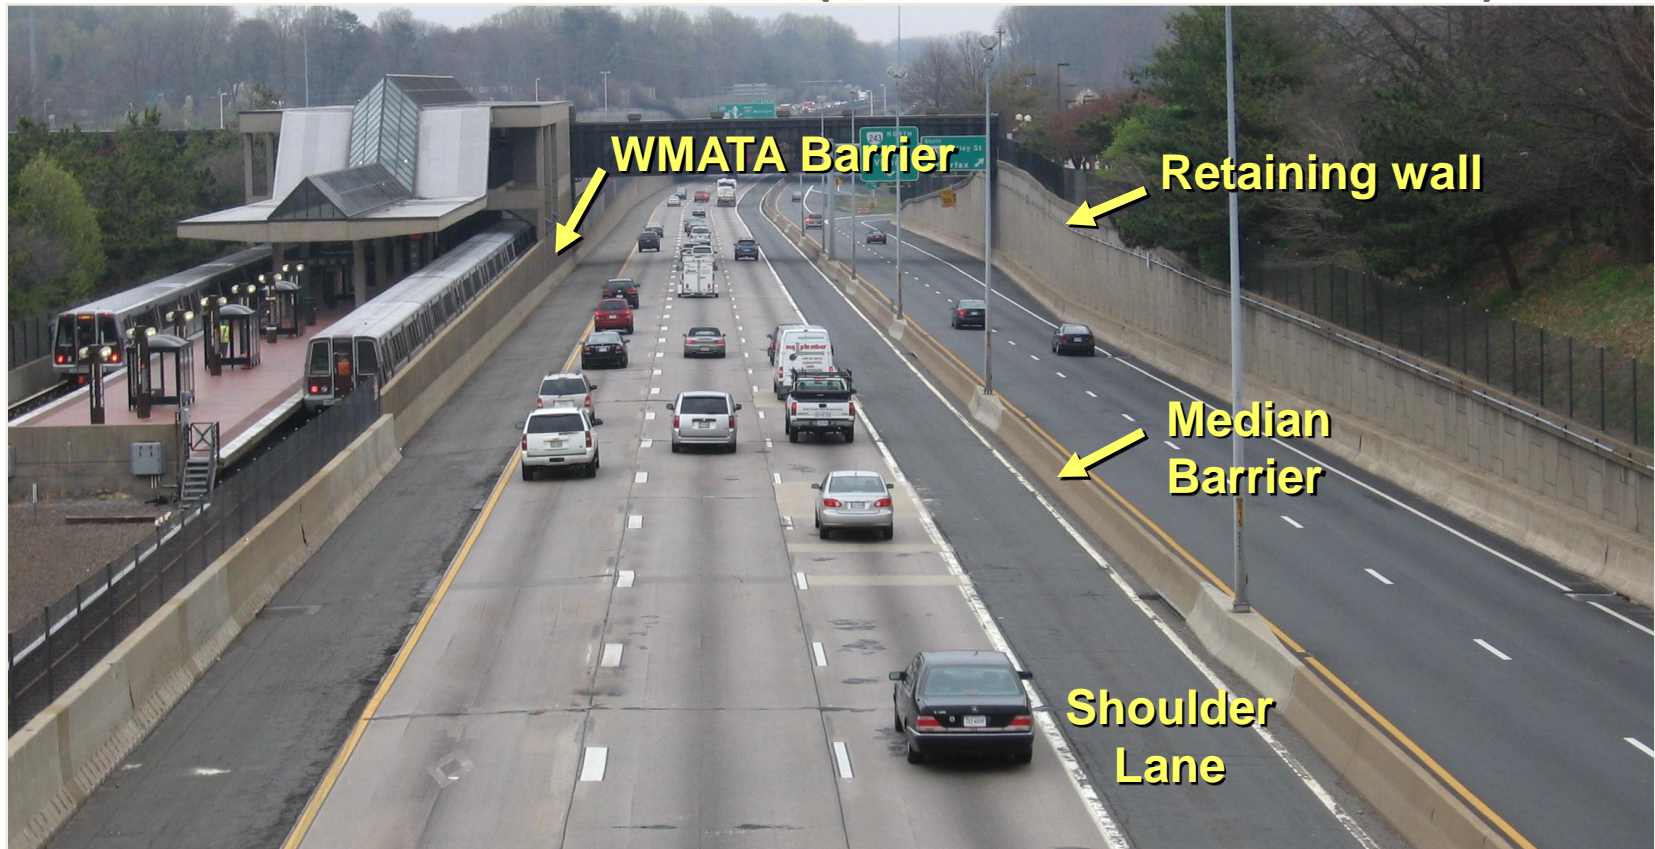
- Concrete Barriers
- Median and WMATA (5 miles “locked in”)

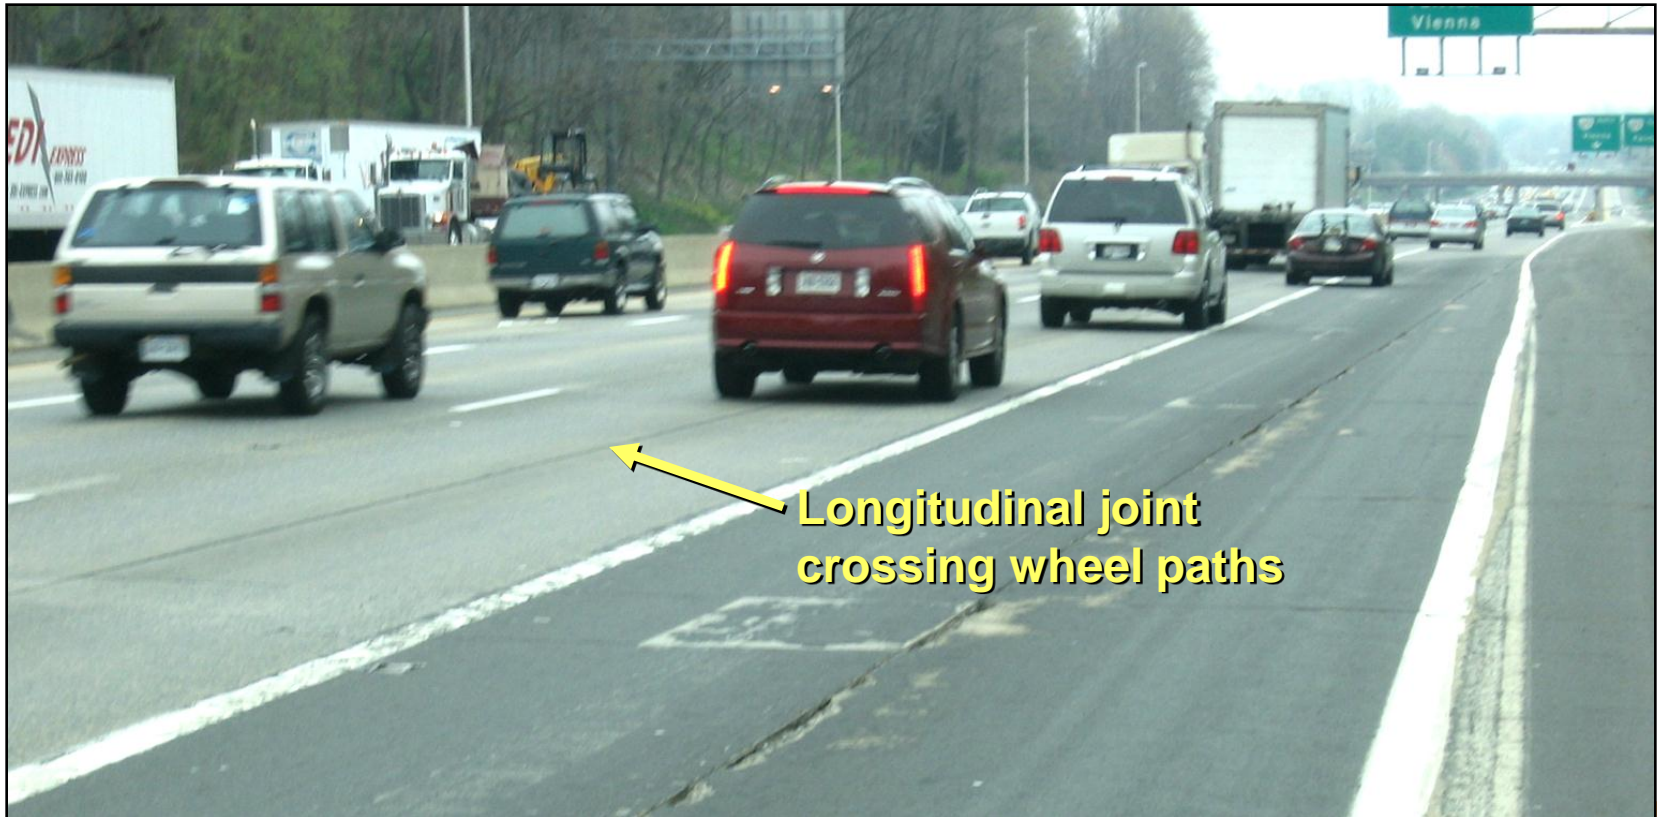
- Lane shifts across Longitudinal Joints in Concrete

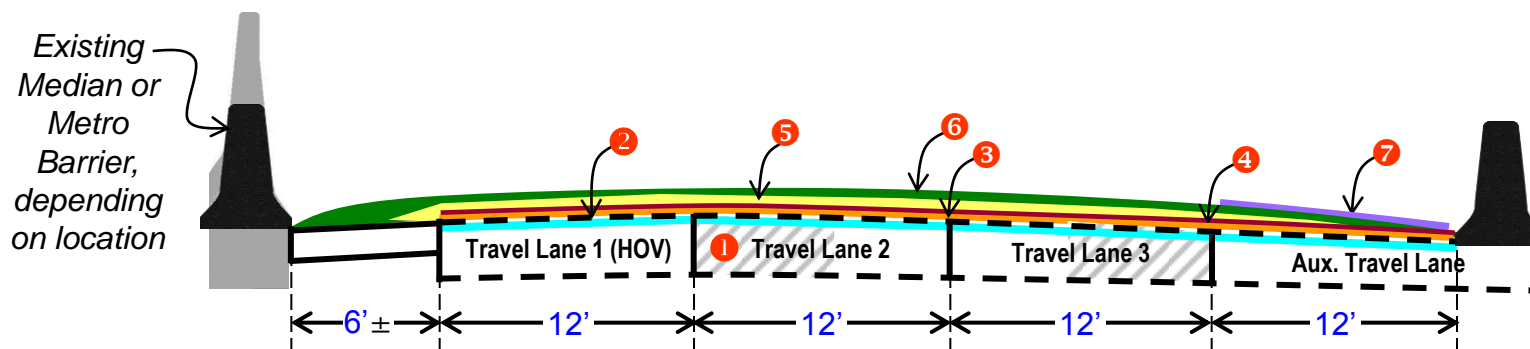
Scope of Work

- ① Patch badly deteriorated concrete pavement with full-depth concrete patches and seal joints
- ② Patch minor spalling with asphalt
- ③ Seal joints, eradicate pavement markings, remove snow plowable raised pavement markers
- ④ Place 5/8" Thin Hot Mix Asphalt Concrete Overlay stress absorbing membrane interface layer
- ⑤ 2" SMA-12.5 (PG 76-22, polymer modified)
- ⑥ 1-1/2" SMA-9.5 (PG 76-22, polymer modified)
- ⑦ 3/8" High Friction Surface Course to delineate auxiliary travel lane

- Issues:
- All existing barriers (both WMATA and median) have 2" reveal; reconstruct/re-face existing barriers but not WMATA barrier due to modifications required for existing drainage inlet throats
- Existing cross slope on auxiliary travel lane varied up to 8.3%; bring this up to standard (except at tapers beneath existing bridges)
- Design exception for cross slope up to 12.6% on inside shoulder
- Taper build-up to zero beneath low clearance bridges; survey and drainage analysis needed
- Adjust drainage inlets and grates in auxiliary shoulder lane

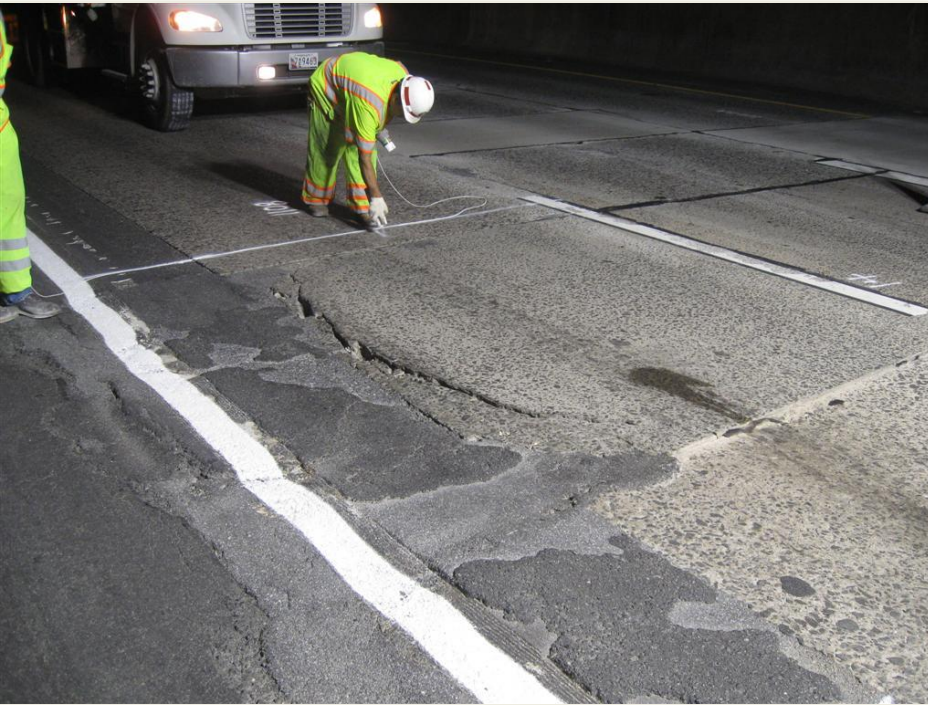
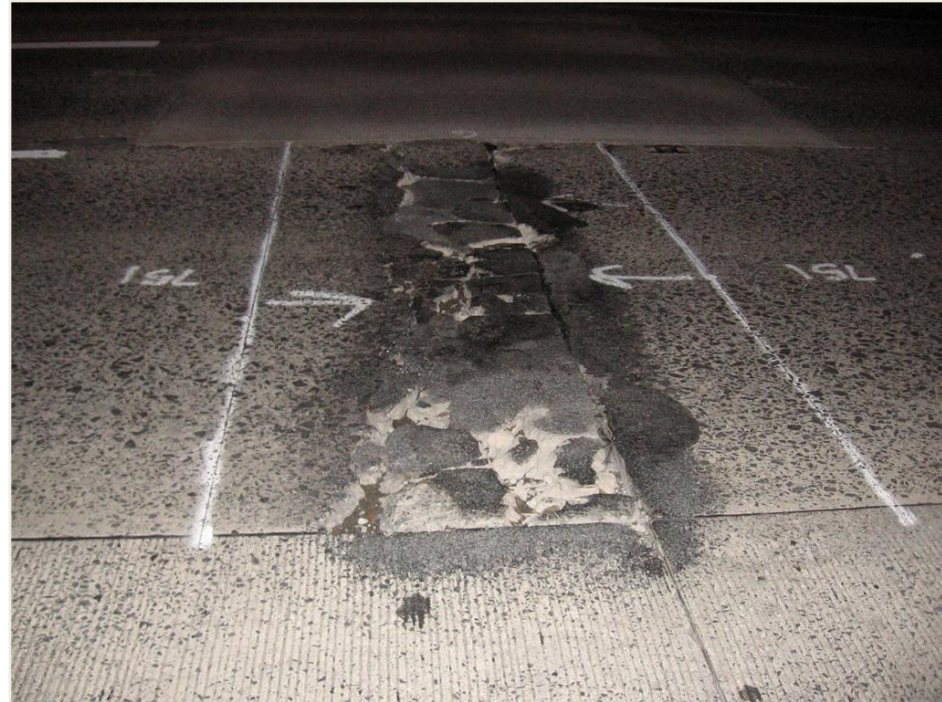
- Extremely rough pavement with failed patches and joints
- Full depth concrete patches

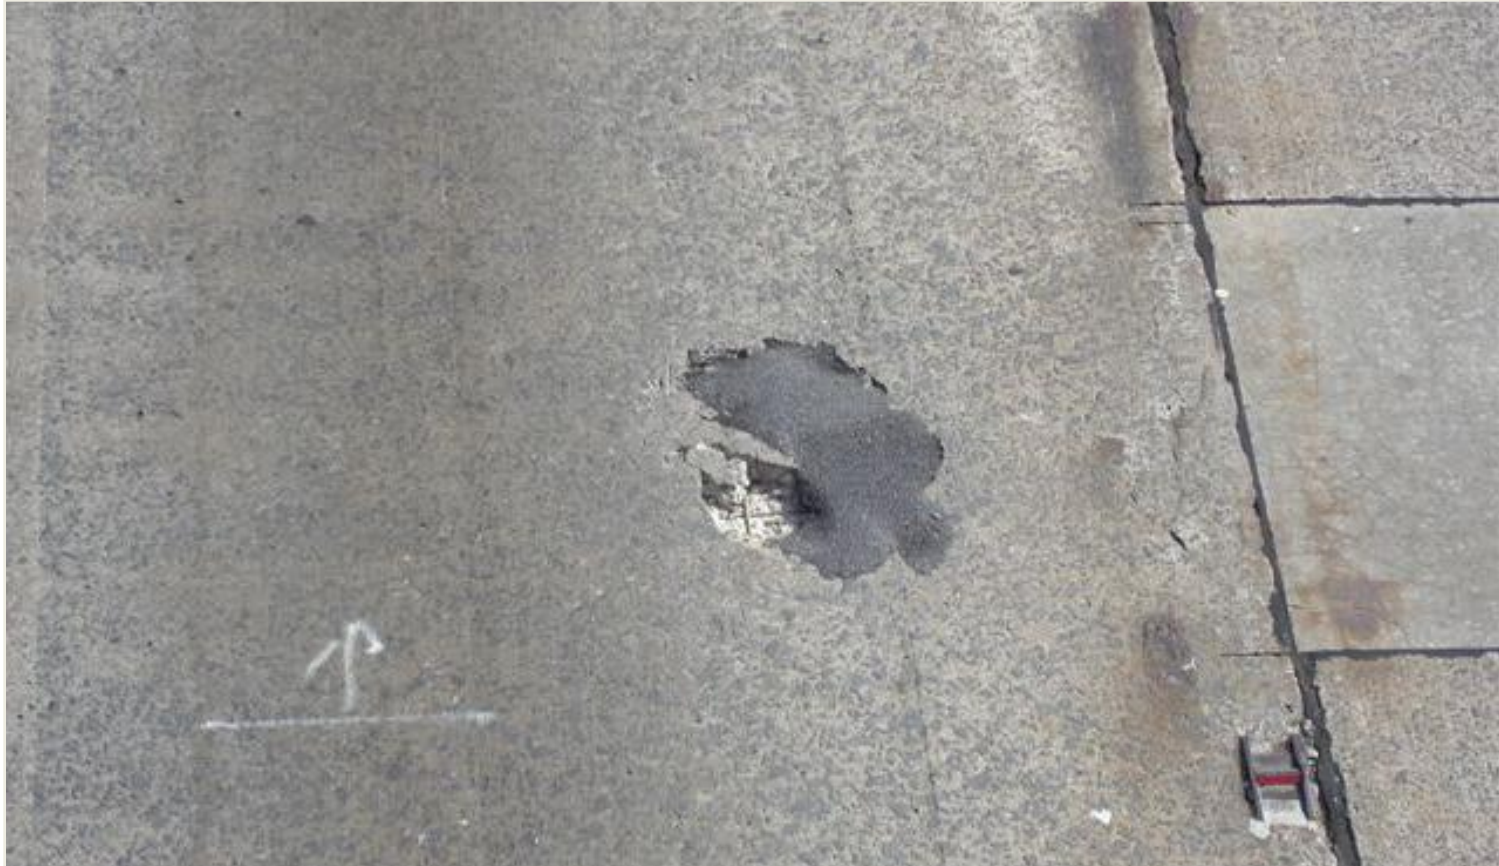
- Patch minor spalls with asphalt or partial depth patches

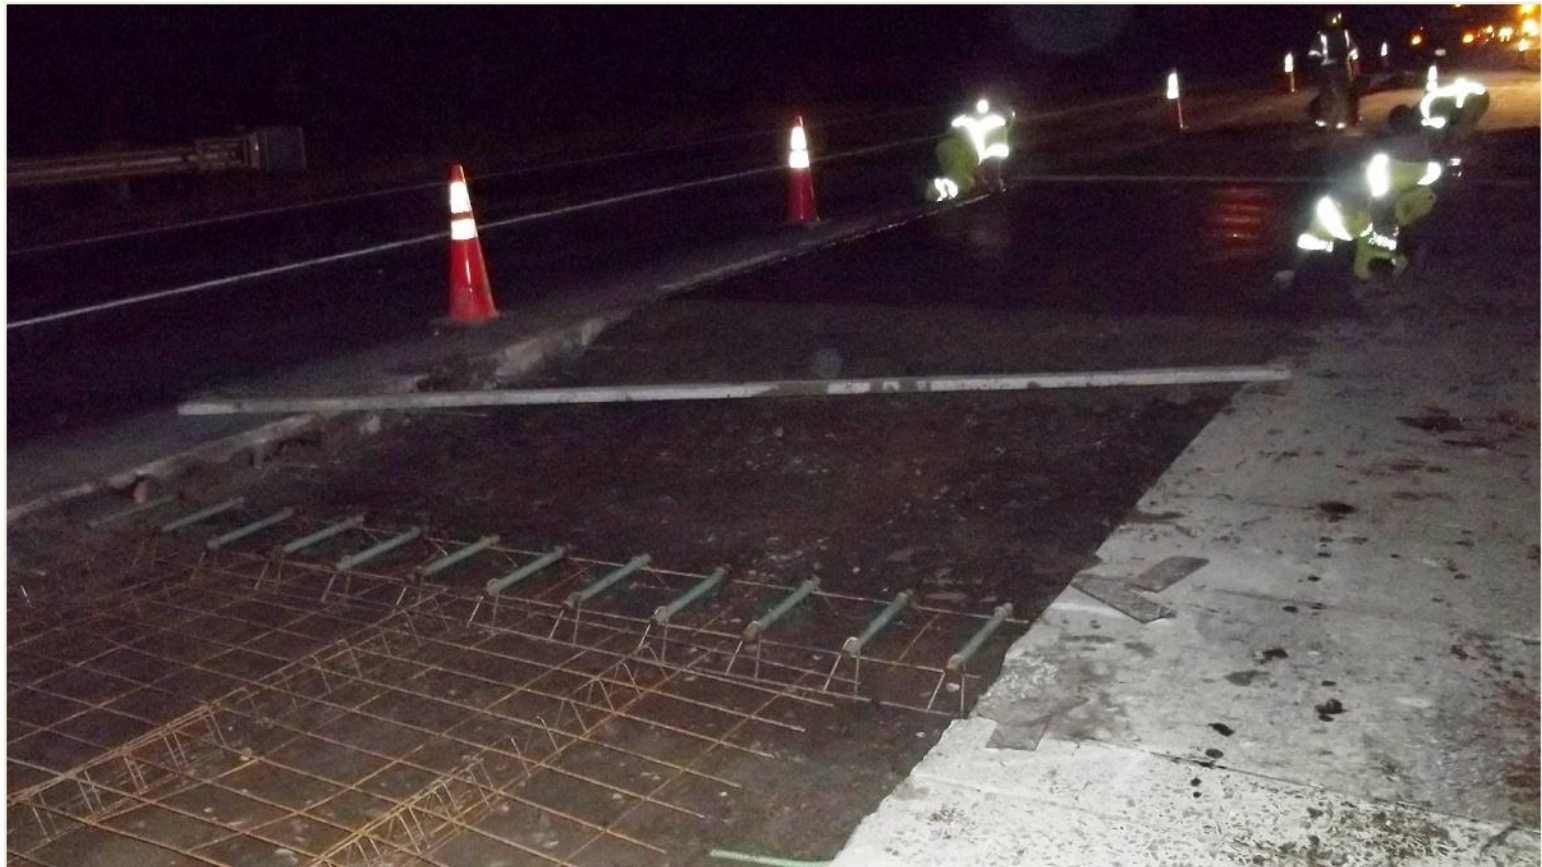
- Total 55,572 sy full-depth (12,004 EB; 36,214 WB; 7,355 on Ramps)
- 4,697 sy partial depth

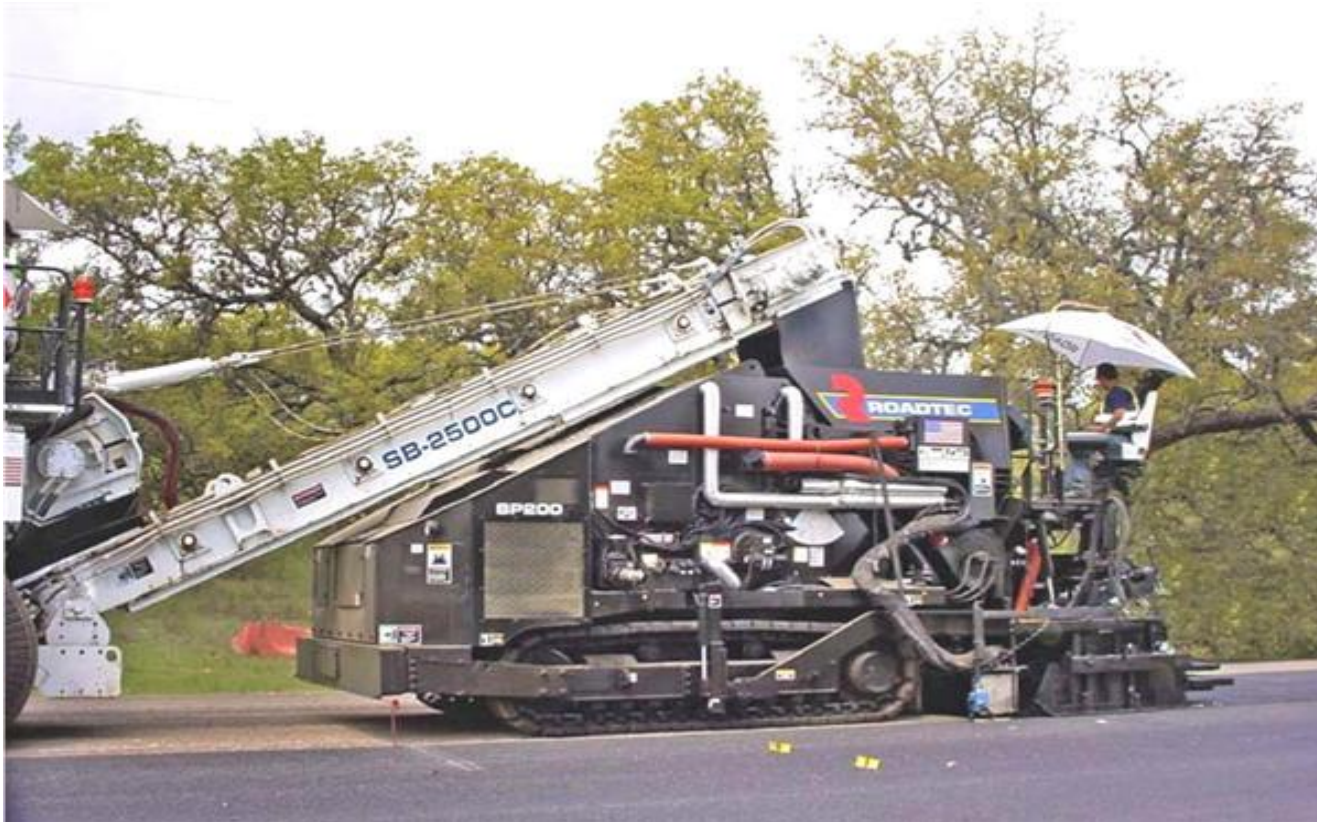
THMACO

- Pavement surface very rough after concrete patches
- Spray bar paver
- Heavy tack

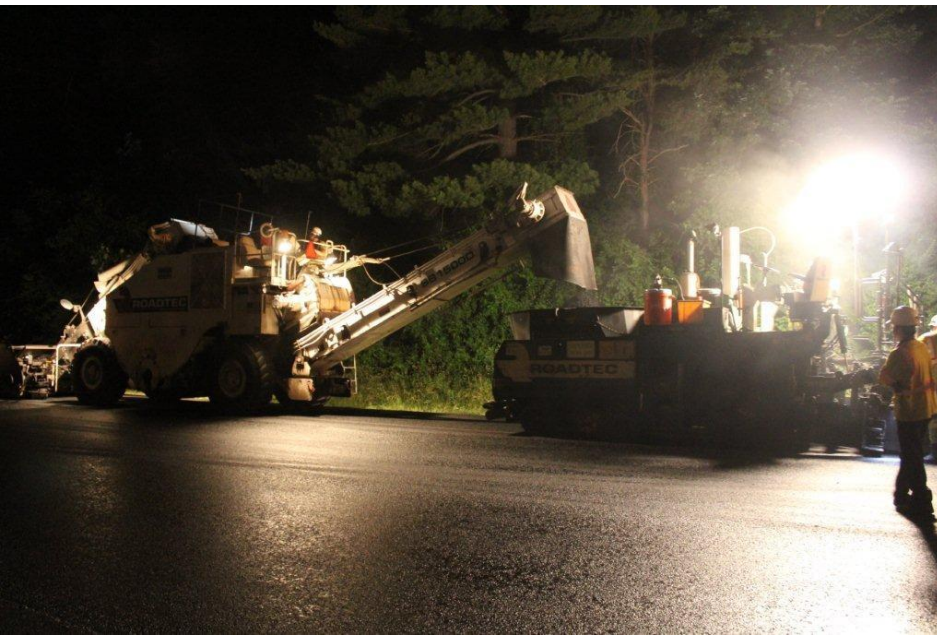
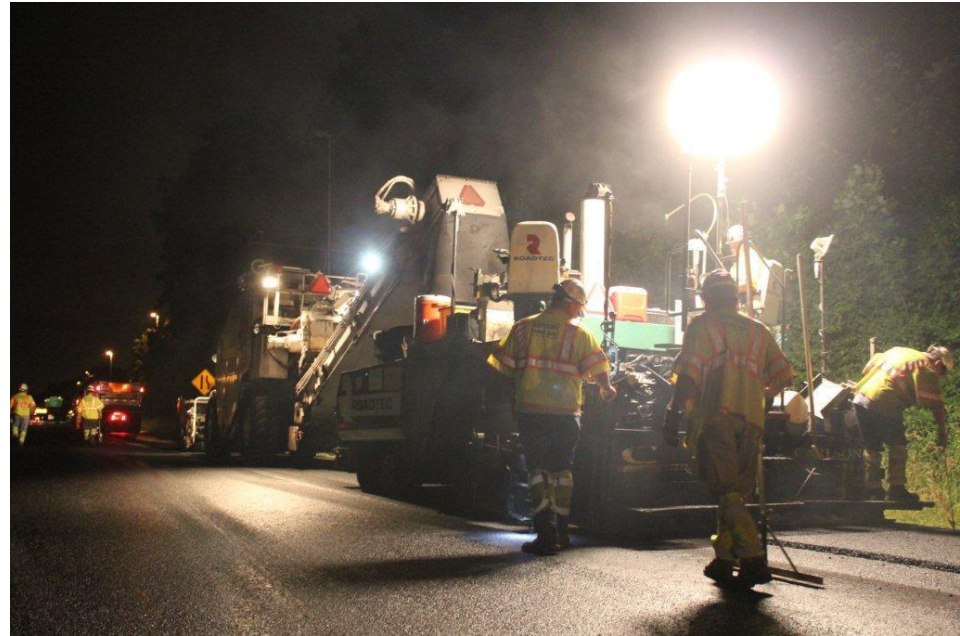
SMA Overlay

- 2" SMA-12.5 (76-22)
- Scratch course for leveling
- 1.5" SMA-9.5 (76-22)

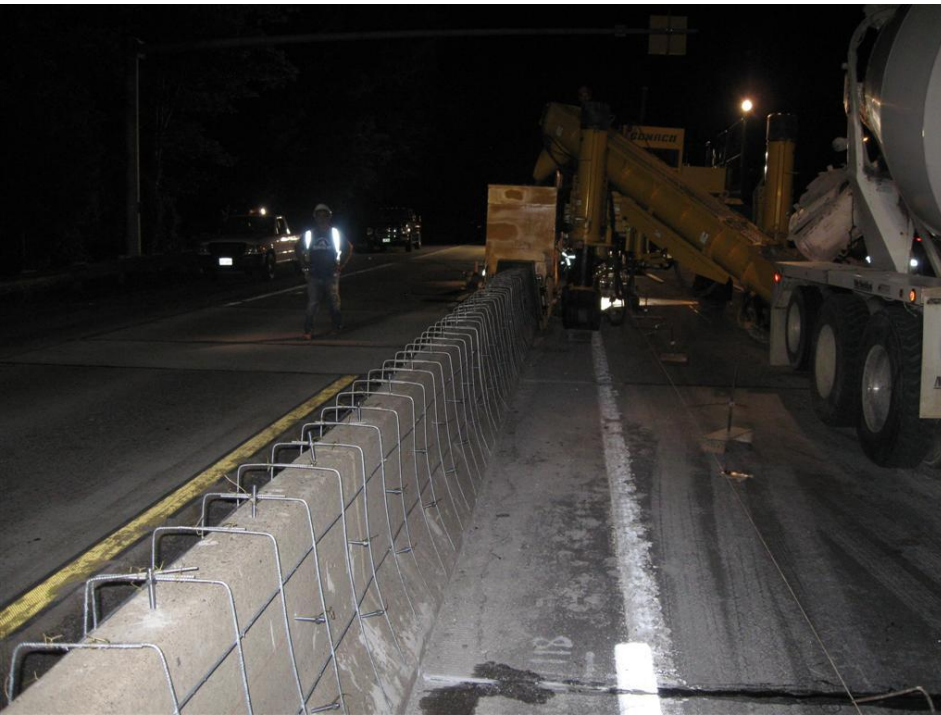
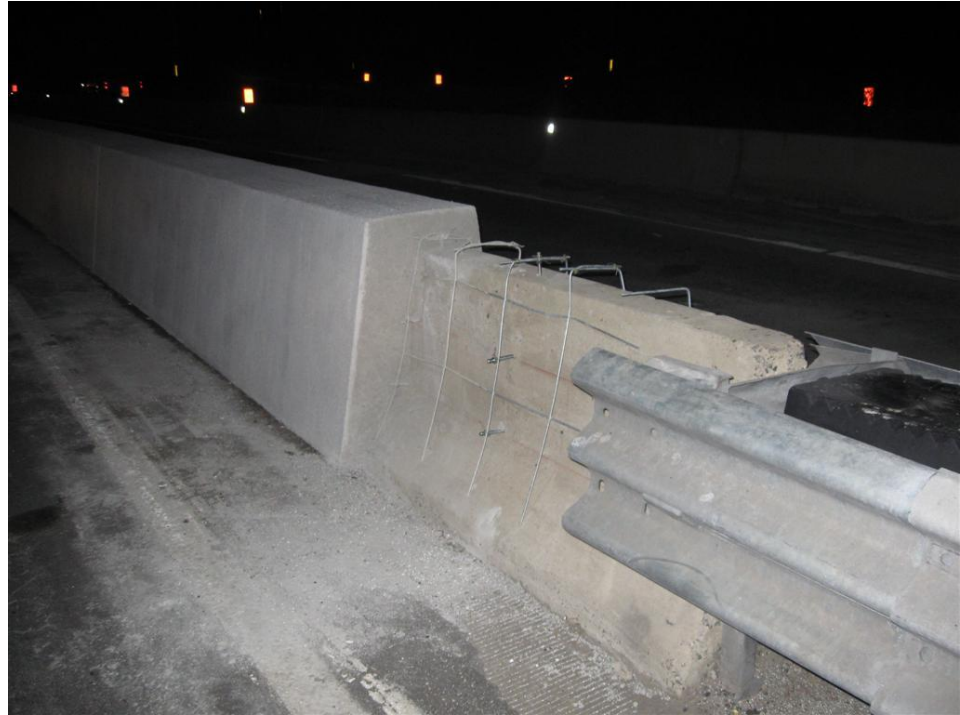
Concrete Jersey Barrier

- Retrofit 23,600 lf with constant slope barrier
- Slip-form over existing barrier
- Drainage inlets required special formwork

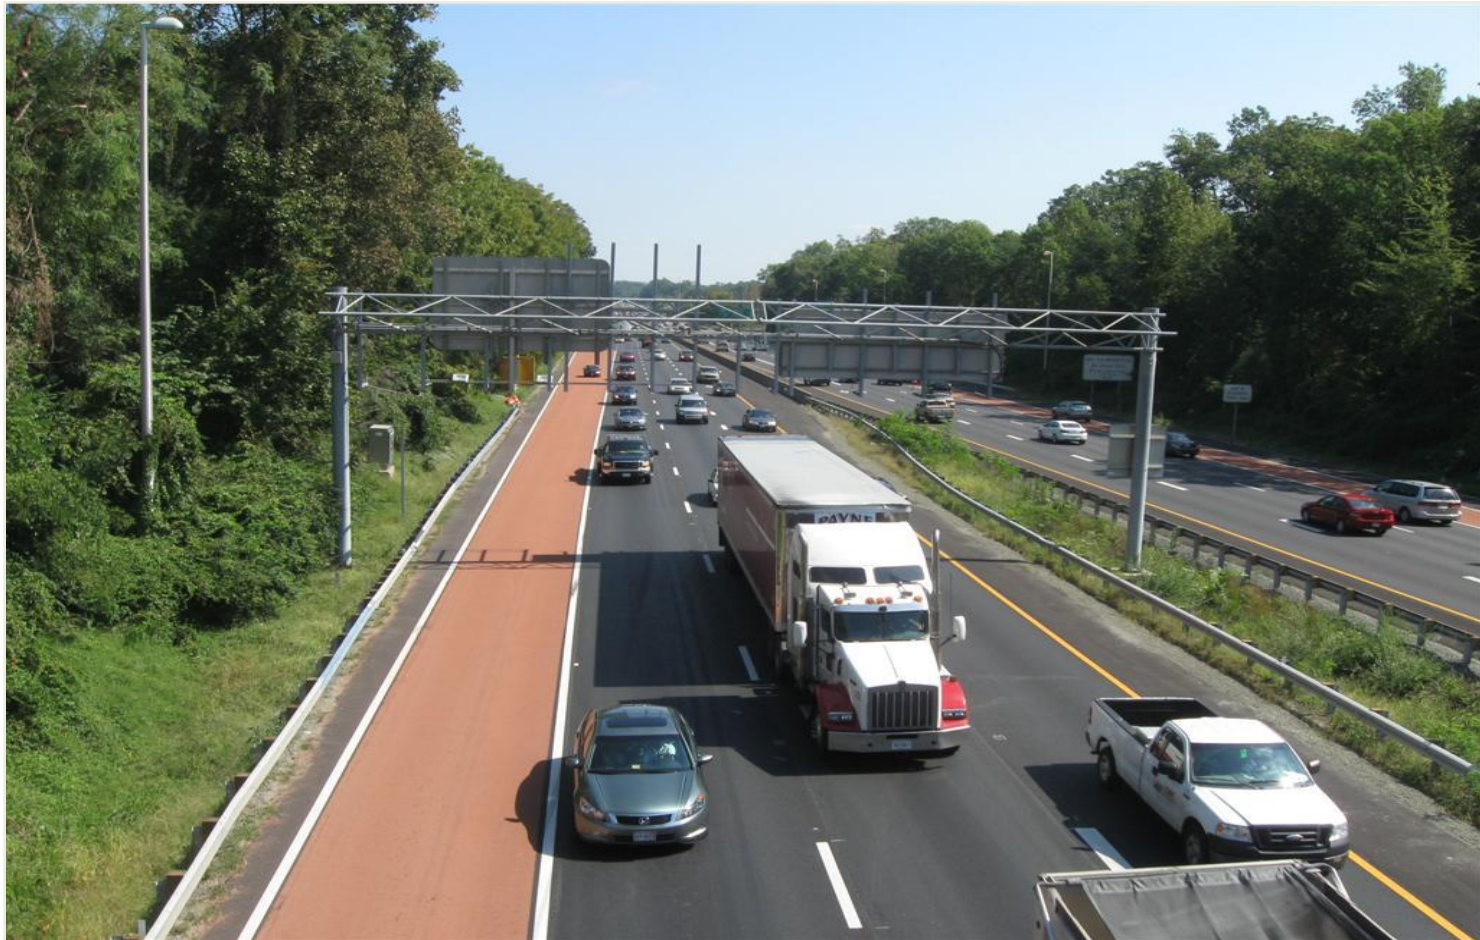
High Friction Surface Course

- Delineate part-time shoulder pavement with a different color as a safety improvement
